Without Wasting a Drop

Robotic Demo Brings Down Aging Water Silos

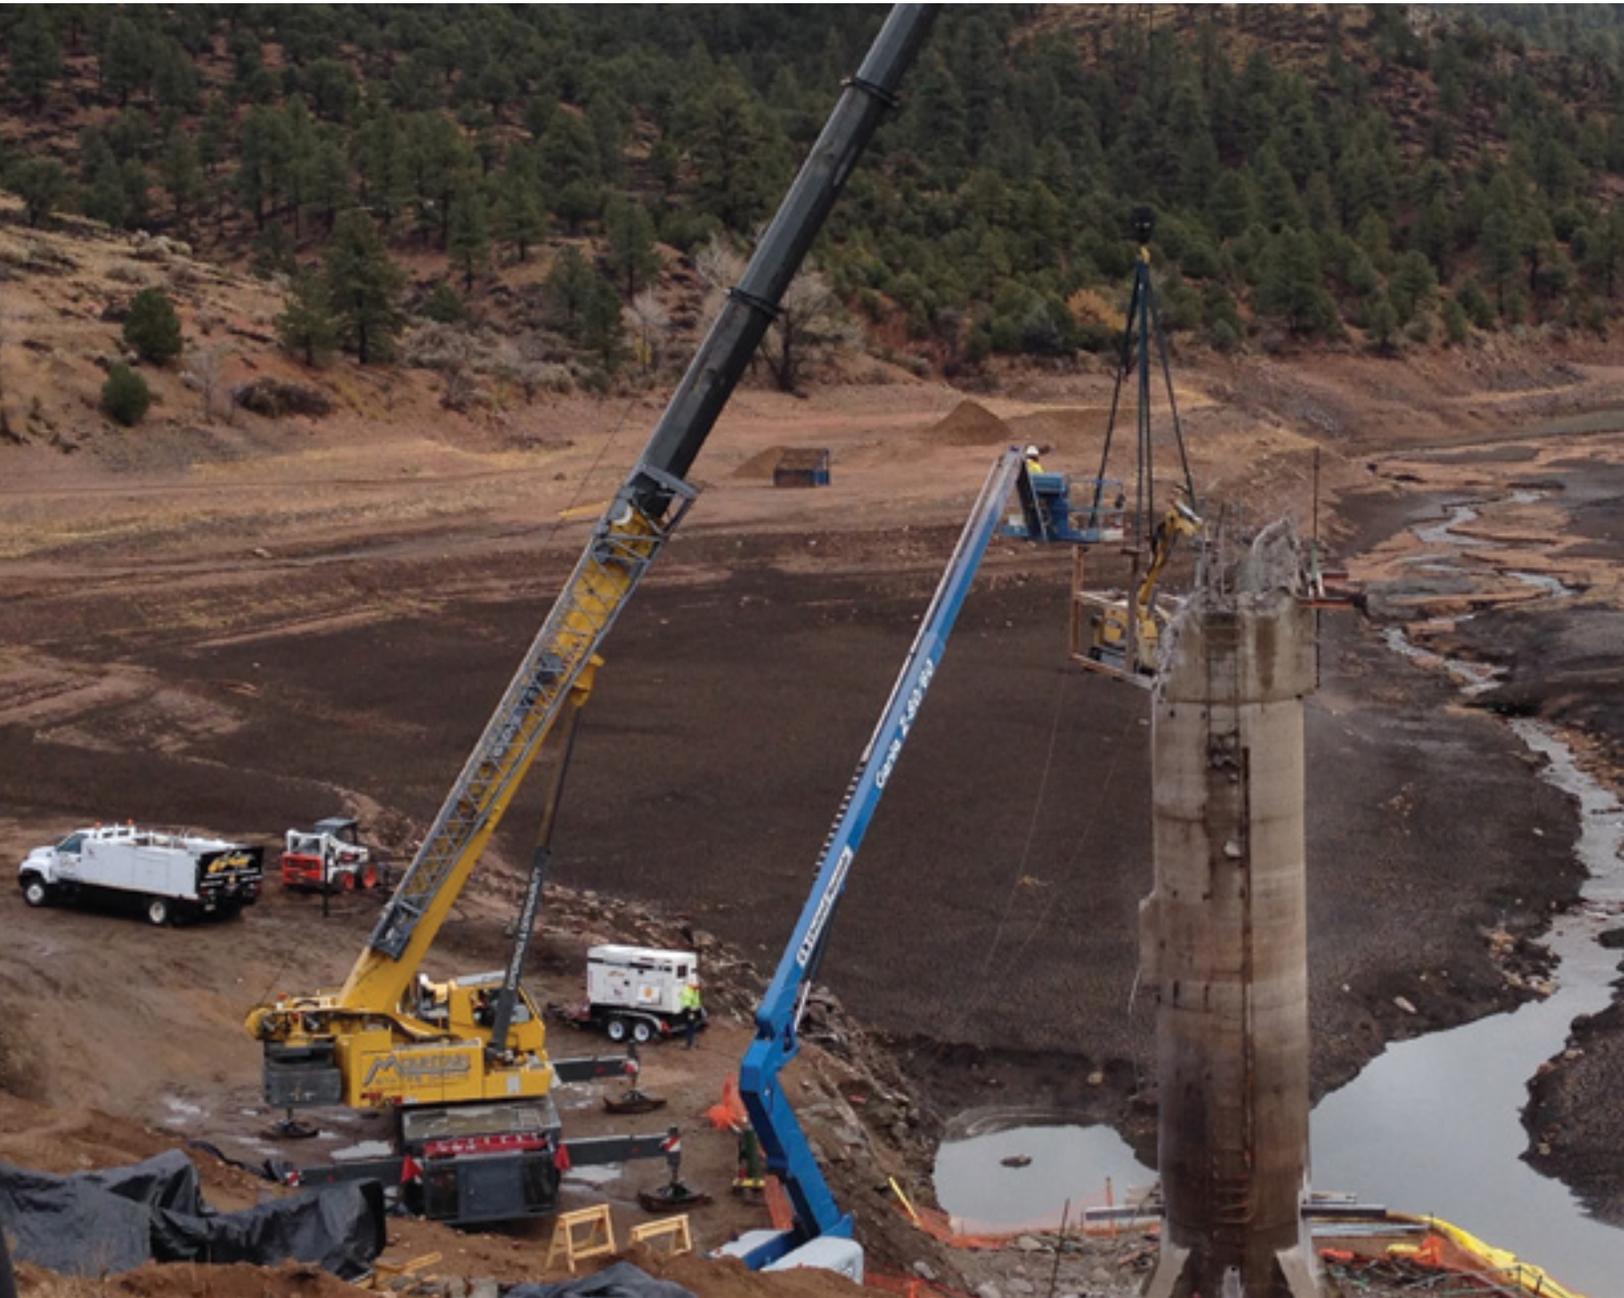
General Contractor RMCI Inc. hired A-Core Inc. to carefully demolish two aging concrete silos in reservoirs in the Sangre de Cristo Mountains east of Santa Fe.

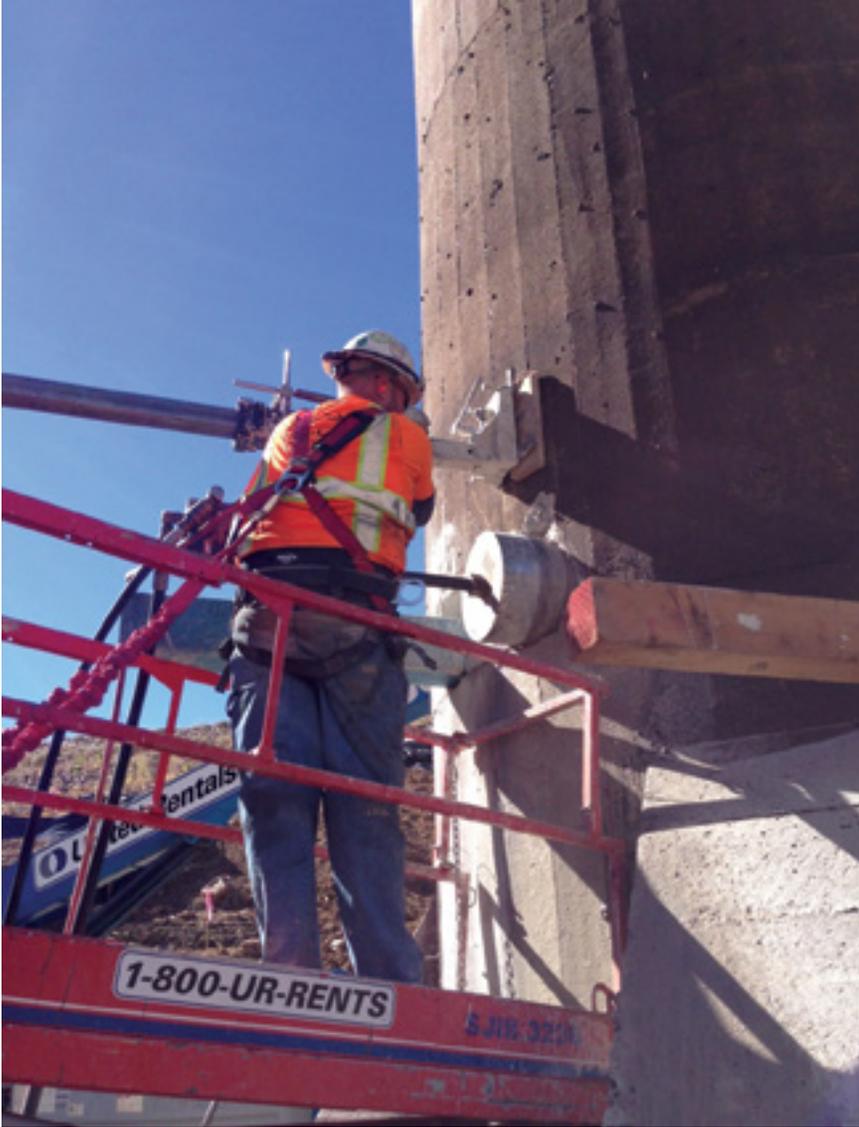
An A-Core operator core drilled 12-inch-diameter holes through one of the silos to insert a steel beam for a work platform.

A-Core determined the best way to contain the debris inside the silos was to build watertight platforms at the elevation they planned to stop hammering. They used Weka and Diamond Products core drills to create 12-inch diameter holes on one side of the silos and 14-inch holes on the other. The crew slid two 10-inch square tube steel beams through to create a base. Then, they core drilled a 30-inch-diameter access hole above the beams. Workers built platforms out of wooden planks that they waterproofed with backer rod before sealing everything with plastic, duct tape and spray foam. Crews buried the inlet structures to control debris from the outside and created working platforms about 40 feet in diameter lined with snow fences.

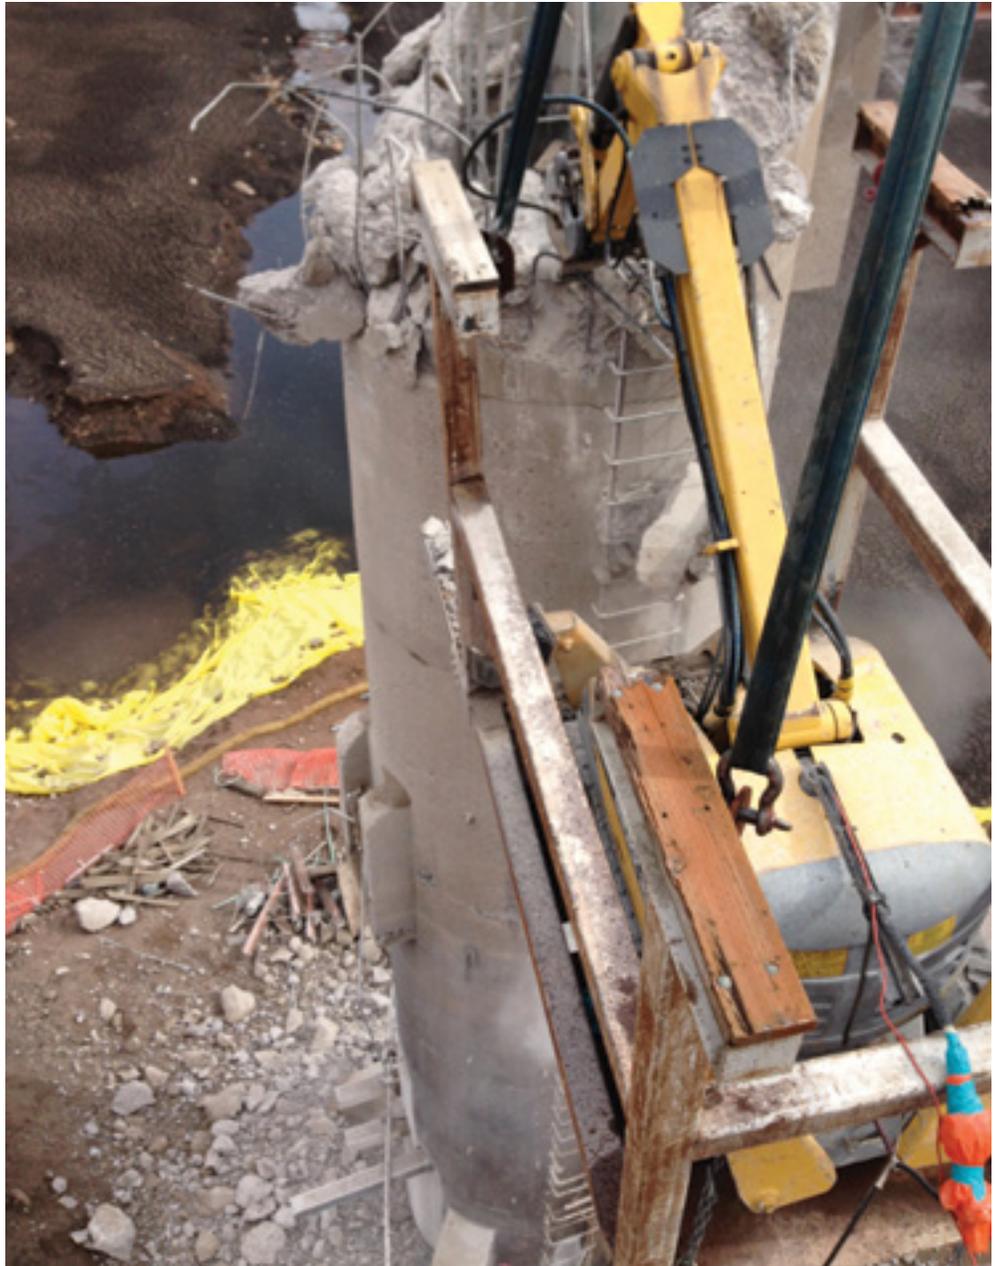
A-Core project manager Ray Chavez chose to use demolition robots because they are powerful enough to break the concrete, but not so powerful to damage the inlet structure below with micro-fracturing.

It was soon apparent that the Brokk 180 wasn’t chipping away at the concrete fast enough. Chavez was prepared for that possibility and brought along a larger Brokk 330D as backup. The crew switched the machines and used the 330D’s 700 foot-pounds of power to break away at the structure.

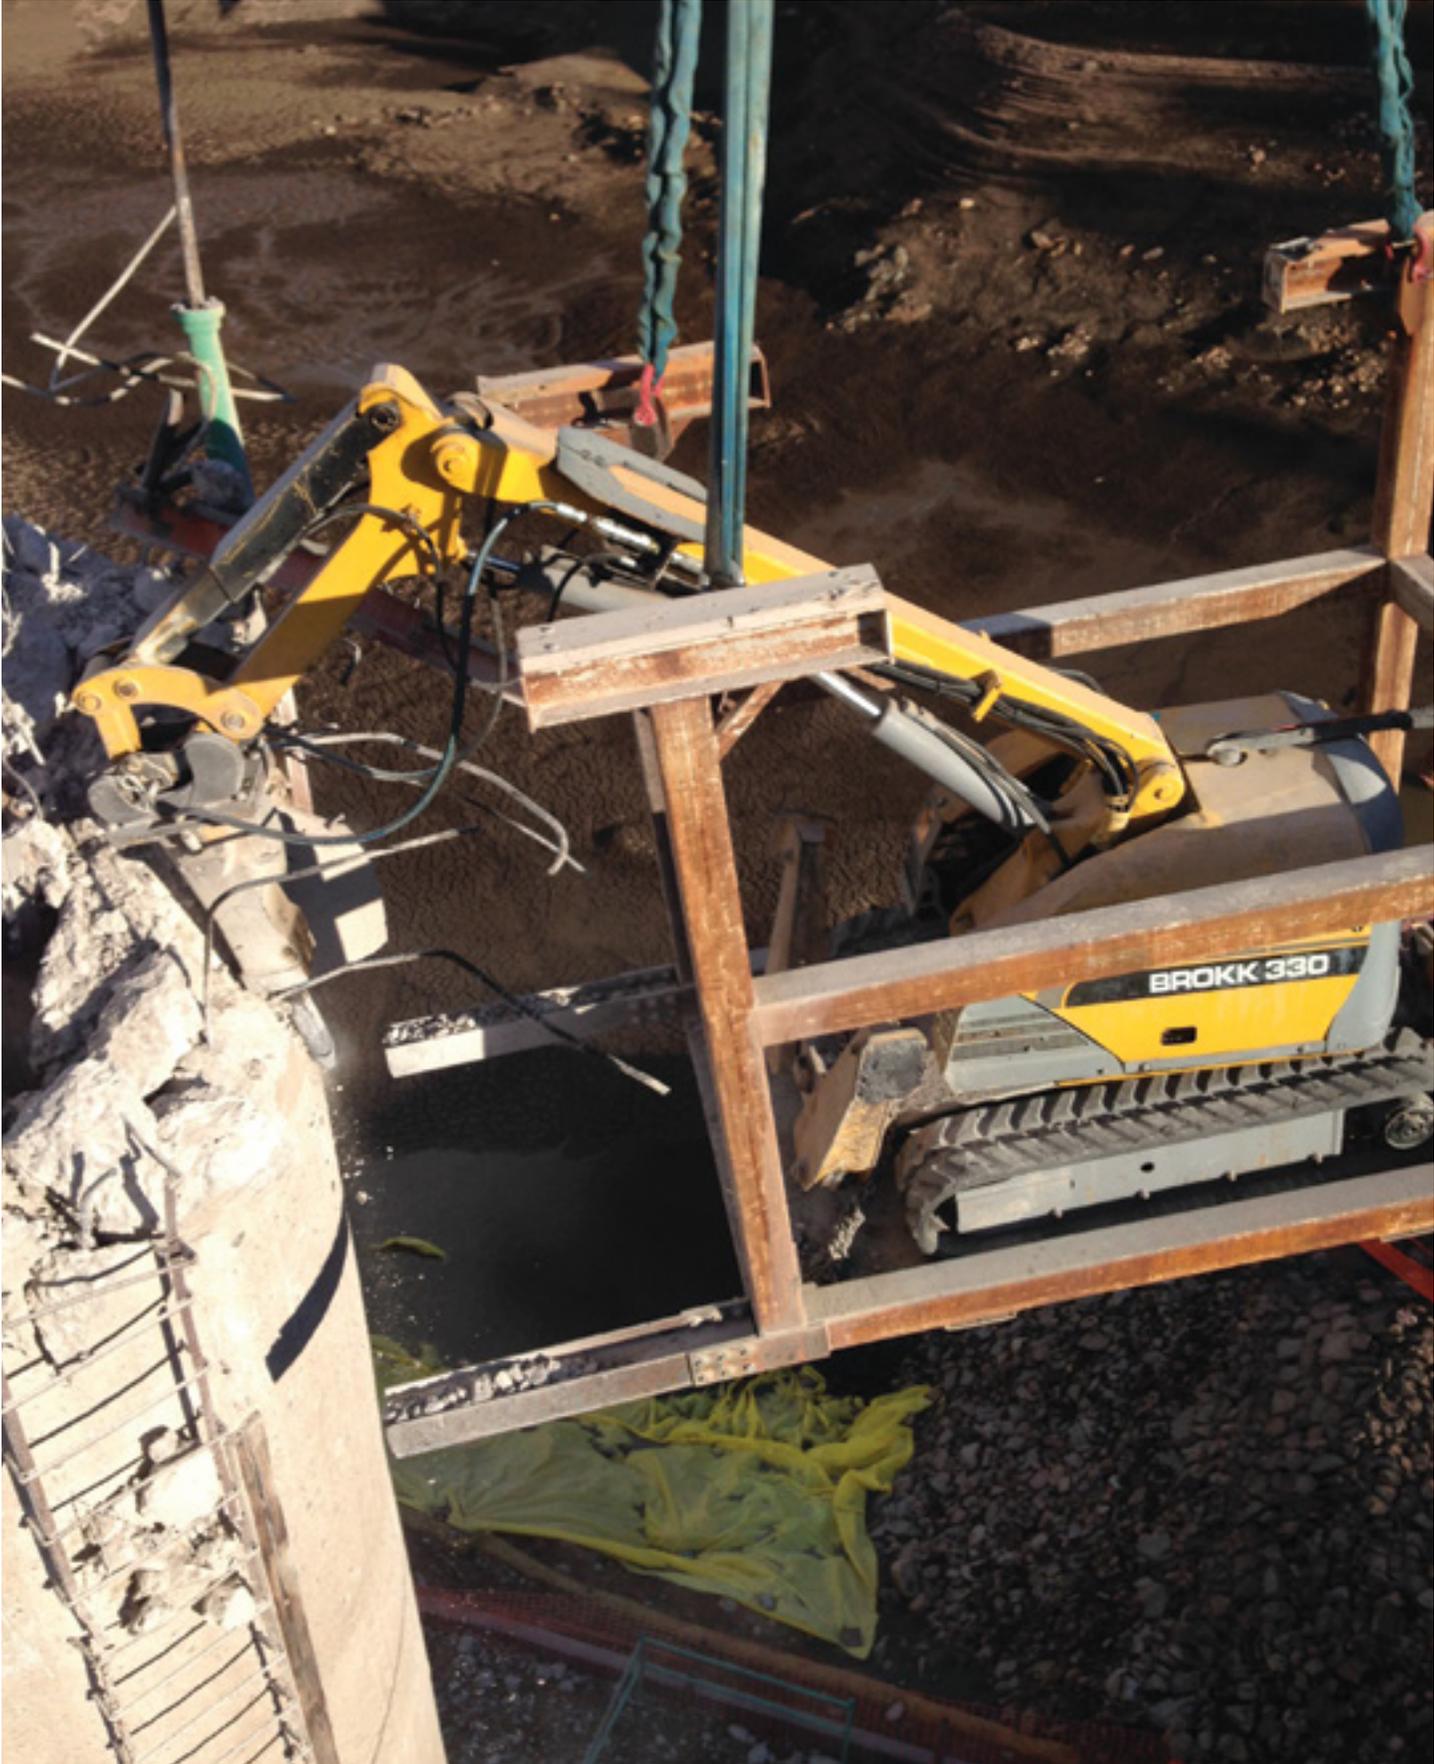
Both silos were broken down to 25-foot buried inlet structures at the bases. RMCI connected the structures to new intakes running up the sides of the dams.

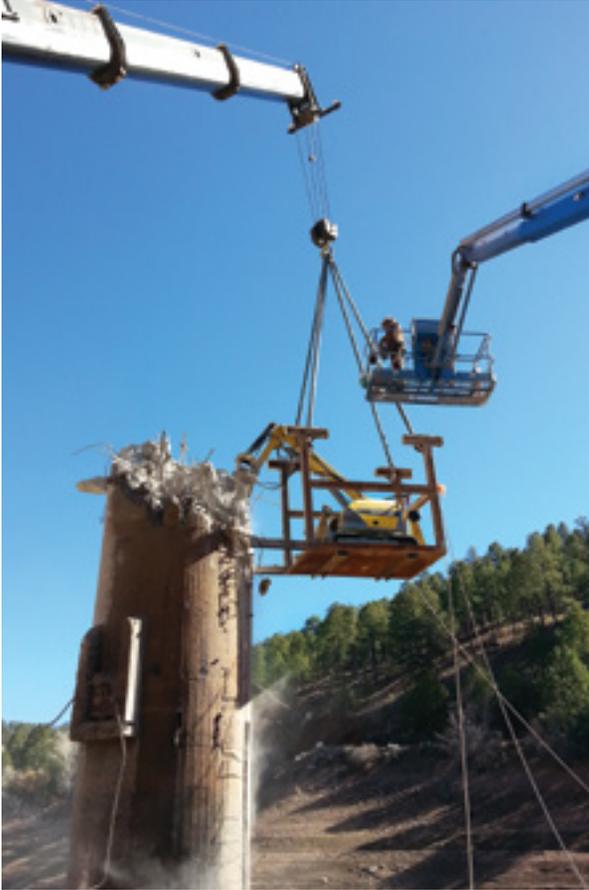
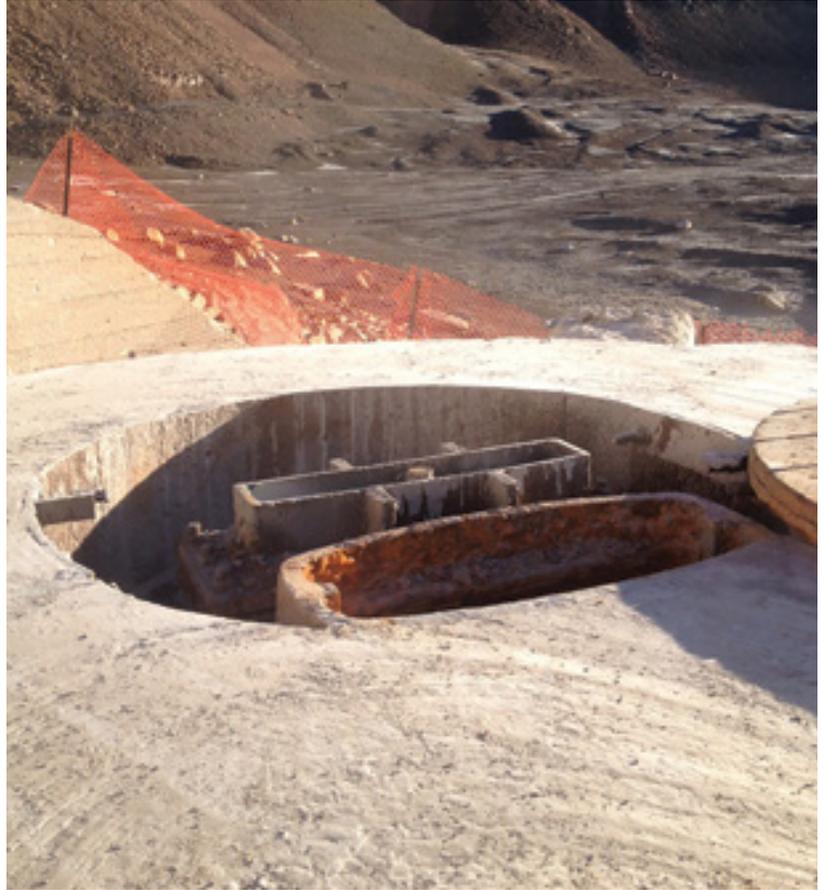
An operator controlled the demolition robot from a boom lift platform about 25 feet away from the machine.
